**State of Utah**  
**DEPARTMENT OF NATURAL RESOURCES**  
**Division of Oil, Gas & Mining**

**Inspection Report**  
**Minerals Regulatory Program**  
**Date: March 15, 2009**

<b>Mine Name:</b> SiO2	<b>Permit Number:</b> M/045/0046
<b>Operator Name:</b> Bolinder Resources	<b>Inspection Date:</b> 10-29-2008
<b>Inspector(s):</b> L Heppler	<b>Time:</b> 5:45 PM
<b>Other Participants:</b> none	<b>Mine Status:</b> ACT

**Purpose of Inspection:** Routine annual inspection

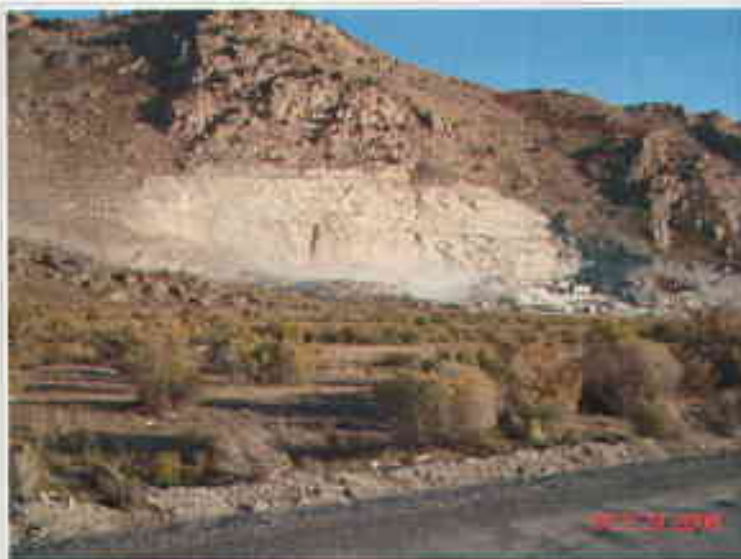
**Inspection Summary:** Disturbed area is compact. Highwall follows dip of bedding. At the time of the field inspection, there was considerable dust coming from the crusher. I informed the operator, that is was not acceptable, he noted that the water pump had just gone out. There was water tank and sprayer system in place for dust suppression. I suggested that he consider adding a backup pump to the system so he could continue to operator in the future when the primary pump goes out.

Dust from processing

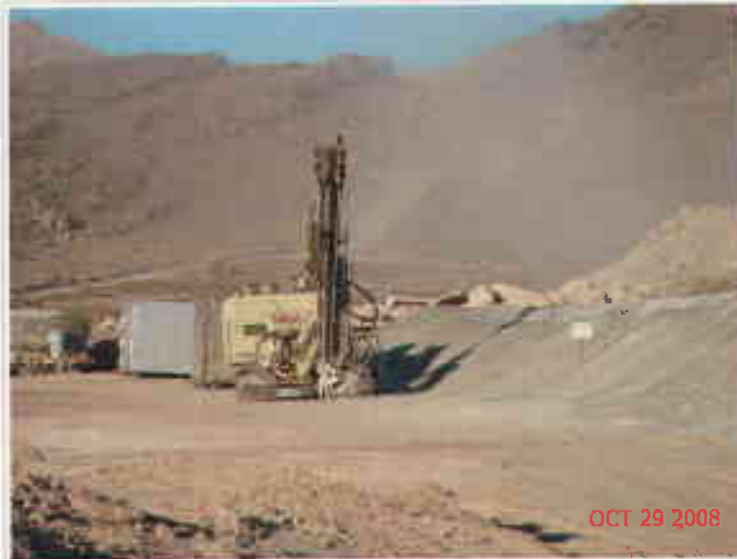
Drill Rig

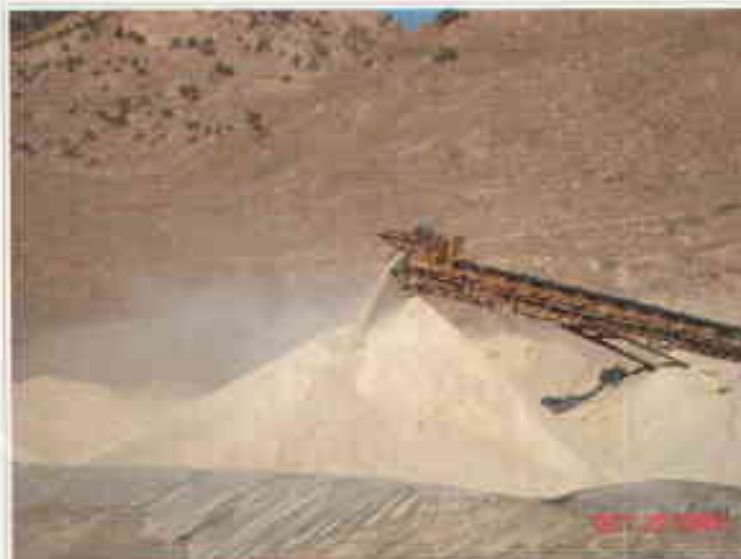
Close up view - Dust from processing

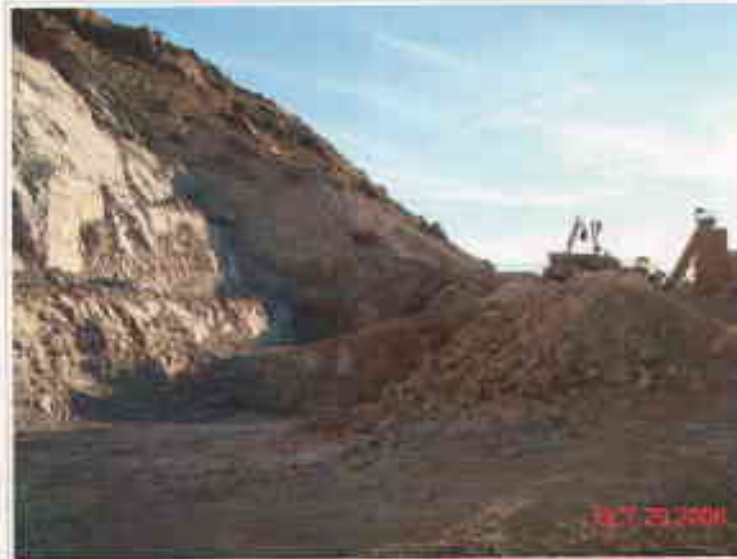
Pit Wall - Note Mine face is parallel to bedding
